SUBJ: EPA Asbestos Removal at 310 Depot Street

REMOVAL ACTION STATUS REPORT DAVIDSON ASBESTOS

Property Address: 310 and 314 Depot Street, Davidson, Mecklenburg County, North Carolina

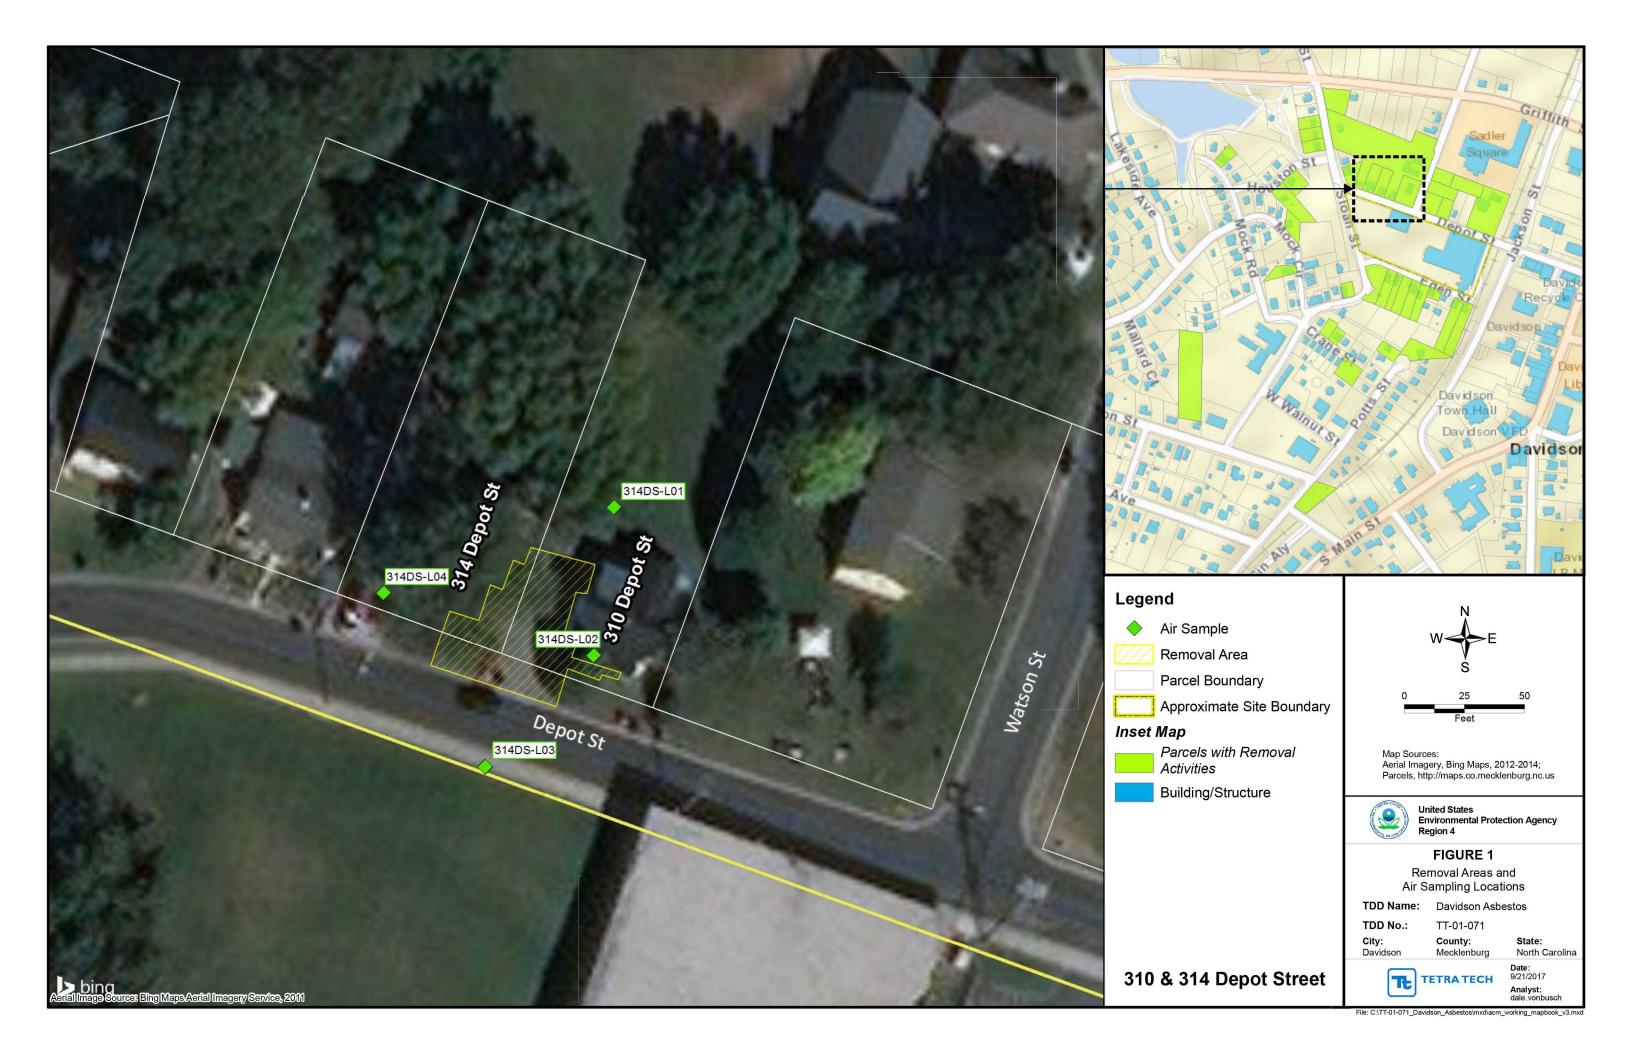
FIGURE

- 1. Figure of removal area and air sampling locations
- 2. Table of air sampling results
- 3. Photographic log of removal activities

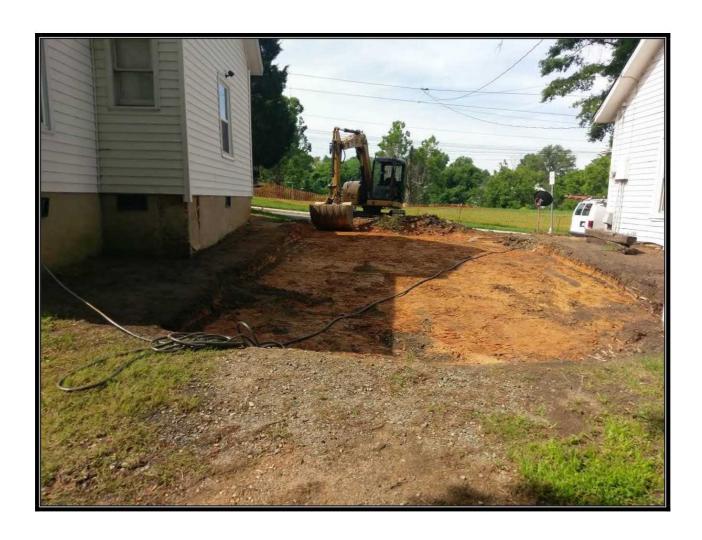
OFFICIAL PHOTOGRAPH NO. 1 U.S. ENVIRONMENTAL PROTECTION AGENCY

Subject: The Emergency and Rapid Response Services (ERRS) contractor, Environmental

Restoration, LLC (ER), used an excavator and hand tools to remove asbestos-containing materials (ACM) and asbestos-contaminated soil from the property located at 310 Depot Street. ER water hoses to wet the asbestos-contaminated soil during removal activities.

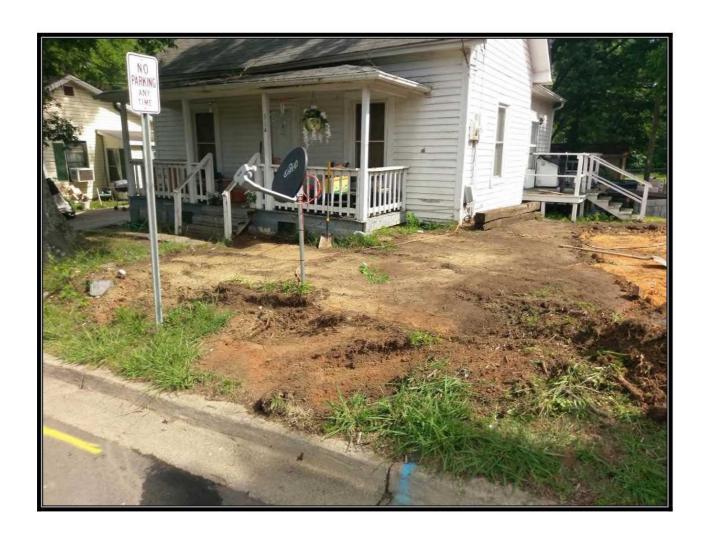
OFFICIAL PHOTOGRAPH NO. 2 U.S. ENVIRONMENTAL PROTECTION AGENCY

Subject: ER used an excavator and hand tools to remove ACM and asbestos-contaminated soil

from the property located at 314 Depot Street. ER used hoses to wet the asbestos-

contaminated soil during removal activities.

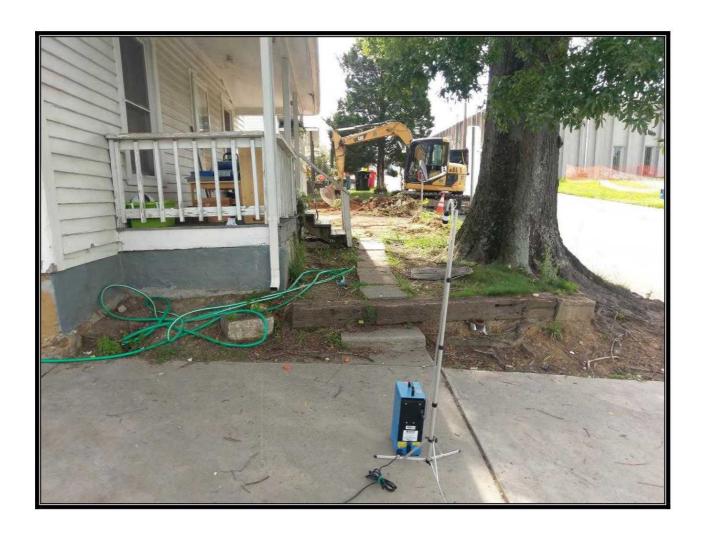
OFFICIAL PHOTOGRAPH NO. 3 U.S. ENVIRONMENTAL PROTECTION AGENCY

Subject: Perimeter air sampling was conducted by a Tetra Tech START, State of North

Carolina-accredited air monitor to evaluate the effectiveness of engineering and safety controls in preventing off-site migration of asbestos fibers during removal activities.

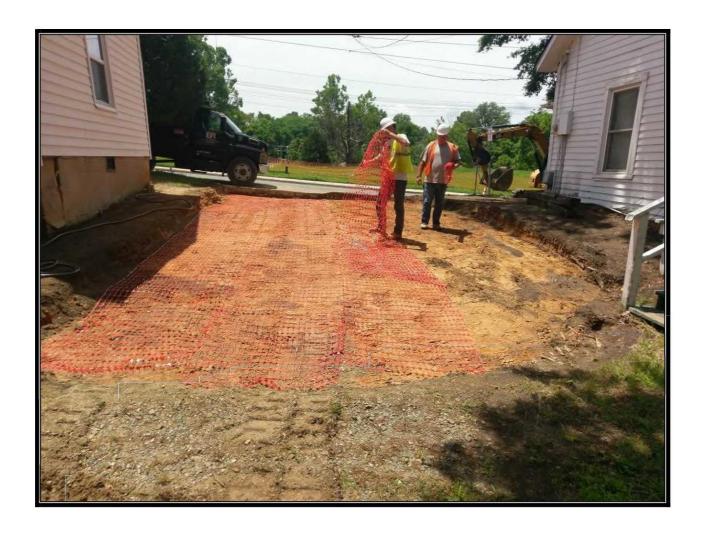
OFFICIAL PHOTOGRAPH NO. 4 U.S. ENVIRONMENTAL PROTECTION AGENCY

Subject: ER installed snow fencing along the subsurface of the excavated driveway area at 310

Depot Street after the inspection conducted by Tetra Tech START, State of North Carolina-accredited asbestos inspector and air monitordetected no visible ACM in the

excavated area.

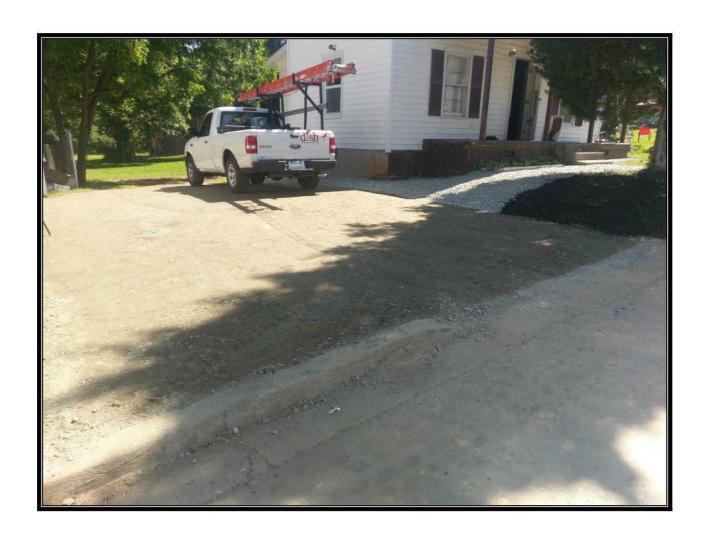
OFFICIAL PHOTOGRAPH NO. 5 U.S. ENVIRONMENTAL PROTECTION AGENCY

Subject: ER installed backfill in the excavated driveway, two separate types of rock between the

driveway and along the southern and western drip lines, and topsoil and mulch under

the tree line of 310 Depot Street.

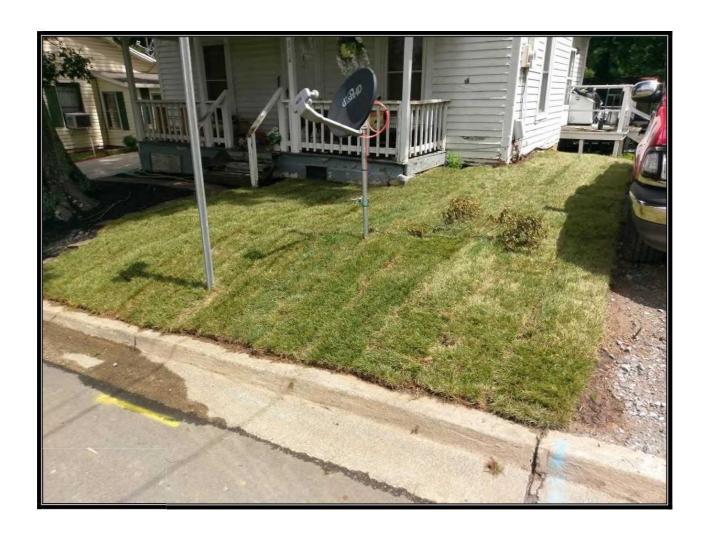
OFFICIAL PHOTOGRAPH NO. 6 U.S. ENVIRONMENTAL PROTECTION AGENCY

Subject: ER installed topsoil and sod along the eastern side and southern yard and topsoil and

mulch under the tree line of 314 Depot Street.
